Module Issue Investigation

The Cause - Dust Incursion

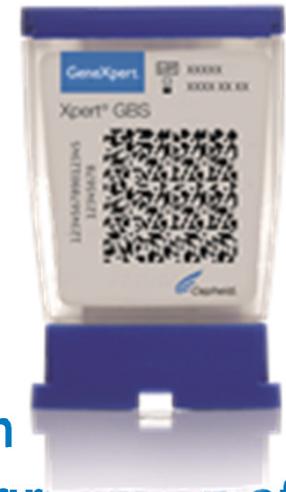
Probe-Check Errors (Error 5007)

- The range of acceptable probe-check values are established for every lot and are transmitted via the bar-code to the GeneXpert
- If the values obtained during probe-check are outside of this range it signifies one of the following conditions:
 - A sample which is too viscous
 - A sample volume of less than 2ml
 - Air bubbles introduced during sample preparation
 - Inappropriate storage conditions have caused degradation of the probes
 - Manufacturing issue (very unlikely as Cepheid's QC procedures are very thorough)
- It is now clear that a rising trend of this error can be symptomatic of a previously un-encountered issue

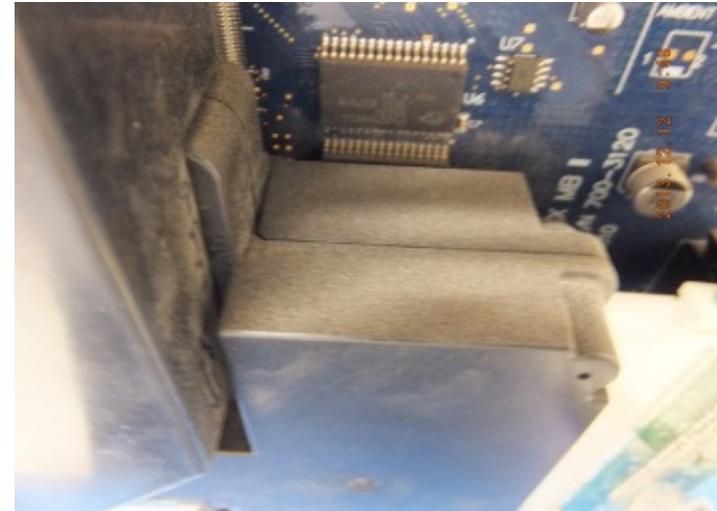
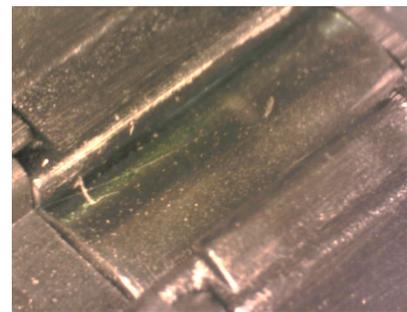
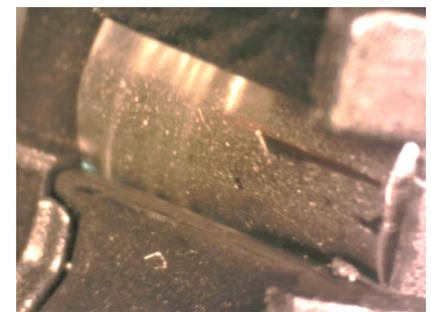
- **Dust enters the instrument and forms a fine layer on the components**
- **Dust enters the module**
 - coating the windows of the emitter and detector blocks
 - Reducing the sensitivity of the module's optics
- **This is both preventable and reversible**

- **Preventative actions:**
 - Tools to be provided to users to allow periodic cleaning of the optical block lenses from outside the module
 - Sensitize users to the cleanliness of the area
- **Corrective actions:**
 - Preventing dust from entering the GeneXpert
 - Replacement rear panel
 - Filter holder relocated to the outside of the rear panel for easy access
 - Filter to be changed for one with a finer pore size
 - Spare filters provided for periodic replacement.
- **Remote Xpert will help to avoid future issues**

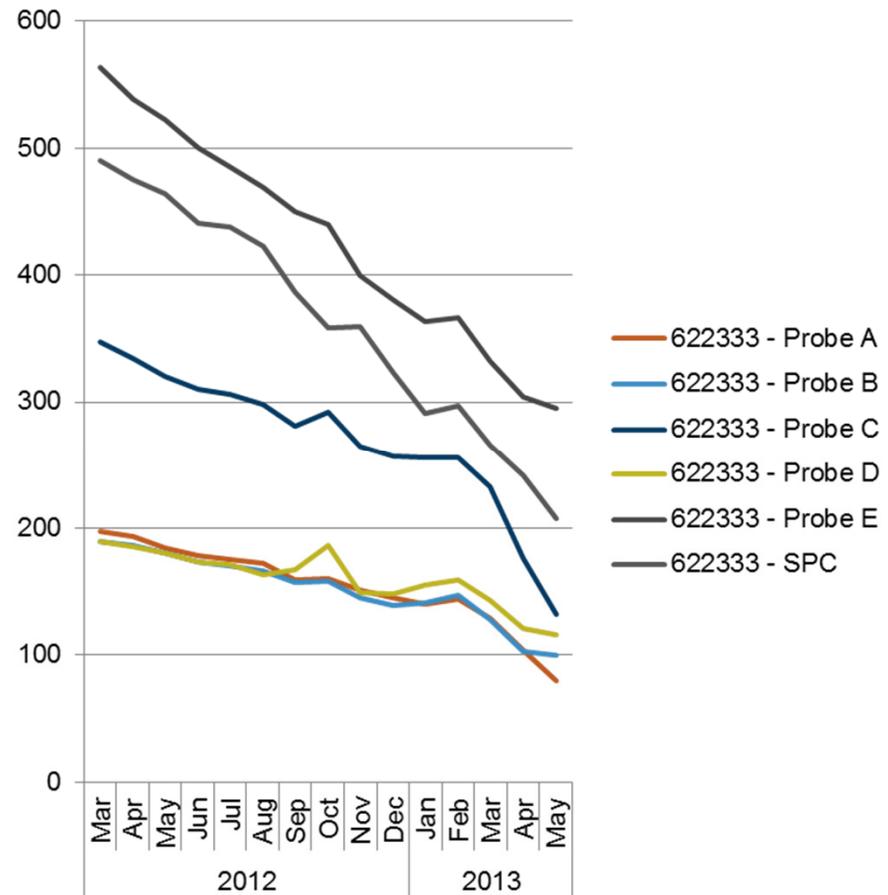
The Effect – Loss of Sensitivity Over Time

- **Sensitivity loss on all channels**
- **Eventually, the minimum fluorescence value is not achieved in one or more channels**
 - **Error 5007 reported**
 - **Cartridge is rejected as the reaction mix is assumed to be defective**

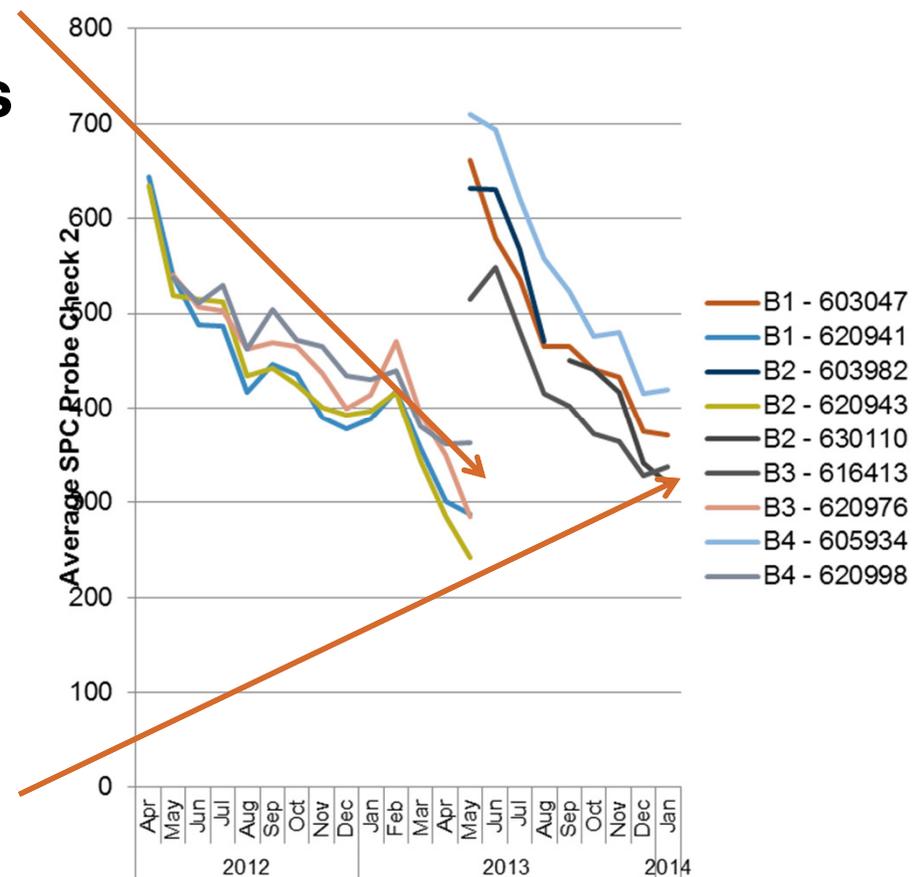
Why Many of the Failures Occur During Recalibration

- **Simultaneous loss of sensitivity in all modules of a system as dust builds**
 - System shares test load between modules
 - Modules aspirate similar quantities of dust
- **Calculated conversion factor is out of range**
 - All modules fail calibration
- **Replacement modules fail more rapidly due to dust-filled cabinet**
