Module Issue Investigation

The Cause - Dust Incursion

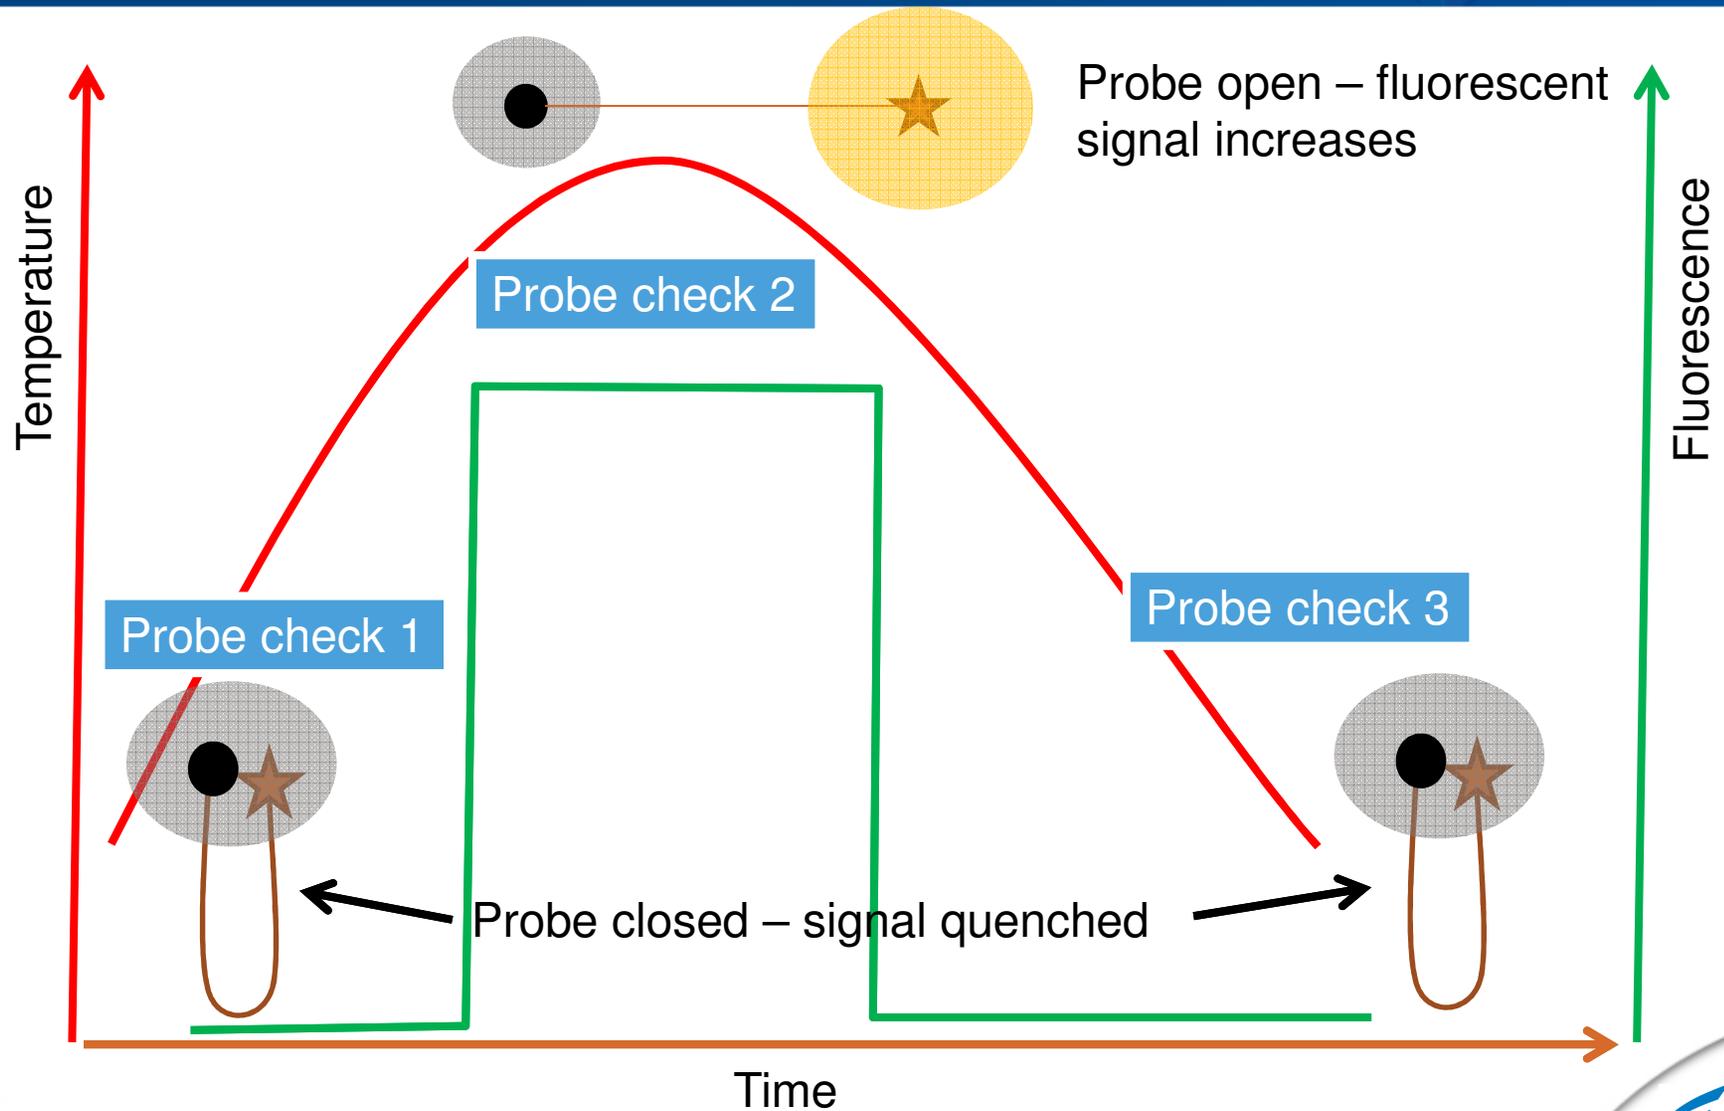
Probe-Check

- **Following sample purification and extraction, the reaction mix is transferred to the reaction tube.**
- **The fluorescence is measured across all channels to obtain a base-line**
- **The reaction mix is heated to 65C and the fluorescence measured again**
 - **At higher temperatures, the probe structure opens and separates the fluorophore and the quencher**
 - **The fluorescence signal increases**
- **The reaction mix is cooled and the fluorescence measured once more**
 - **The fluorescence signal decreases once more to the base-line**

- The range of acceptable probe-check values are established for every lot and are transmitted via the bar-code to the GeneXpert
- If the values obtained during probe-check are outside of this range it signifies one of the following conditions:
 - A sample which is too viscous
 - A sample volume of less than 2ml
 - Air bubbles introduced during sample preparation
 - Inappropriate storage conditions have caused degradation of the probes
 - Manufacturing issue (very unlikely as Cepheid's QC procedures are very thorough)
- It is now clear that a rising trend of this error can be symptomatic of a previously un-encountered issue
